## BRIDGE NO. 116022

63480 – REDDING  
BROOKSIDE ROAD  
over  
GILBERT BENNETT BROOK

In-Depth Inspection  
03/14/2025  
Inspected by: Tighe & Bond

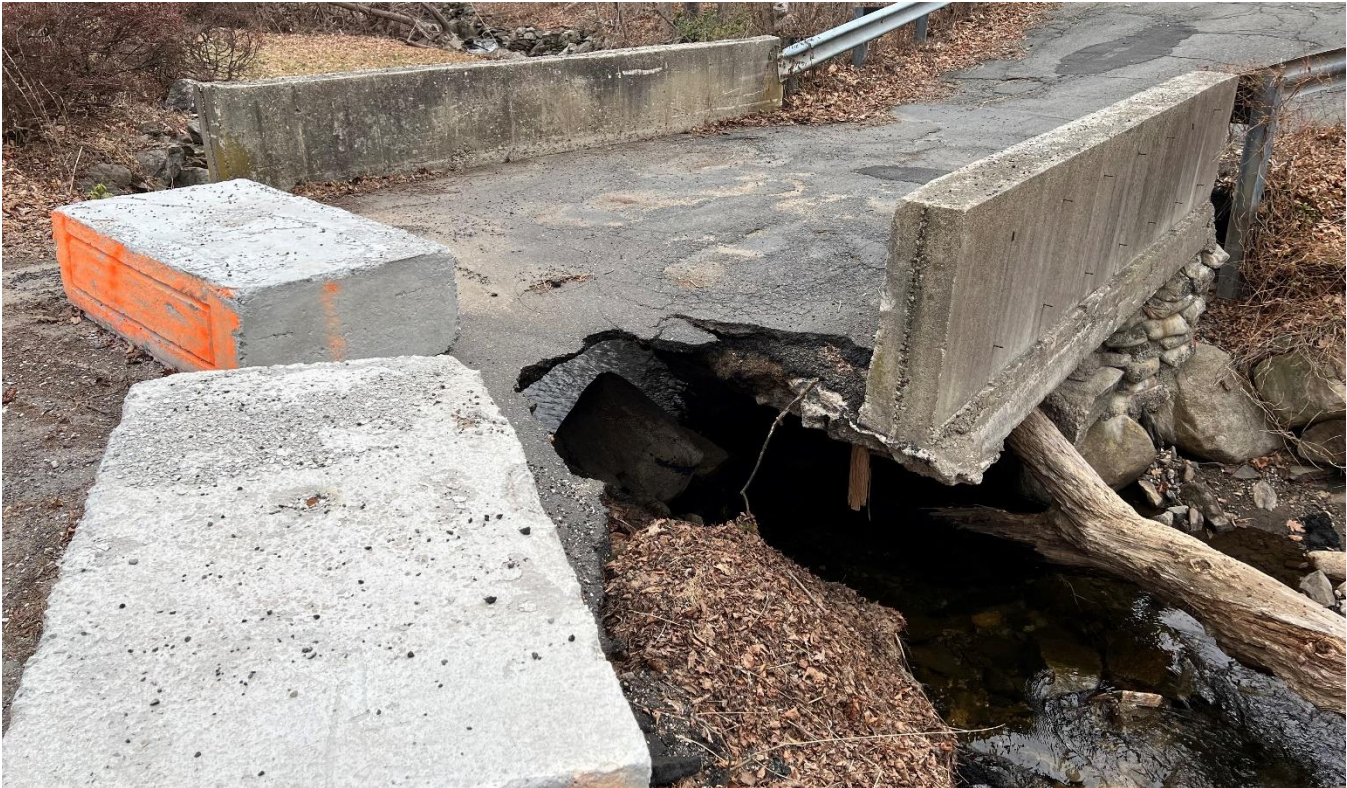
Photo Number: 3

| Approach Pavement: | 0 | There is a large hole in the approach pavement adjacent to the southern end of the west abutment, which was lost in a severe washout. The pavement adjacent to the hole is unsupported, and additional collapse is possible.<br><br>The approach pavement at the east approach is heavily cracked. Some undermining is visible from the southeast corner of the bridge, extending to the middle of the east abutment. |

Bridge from west approach.  
Note collapsed pavement and  
missing abutment.

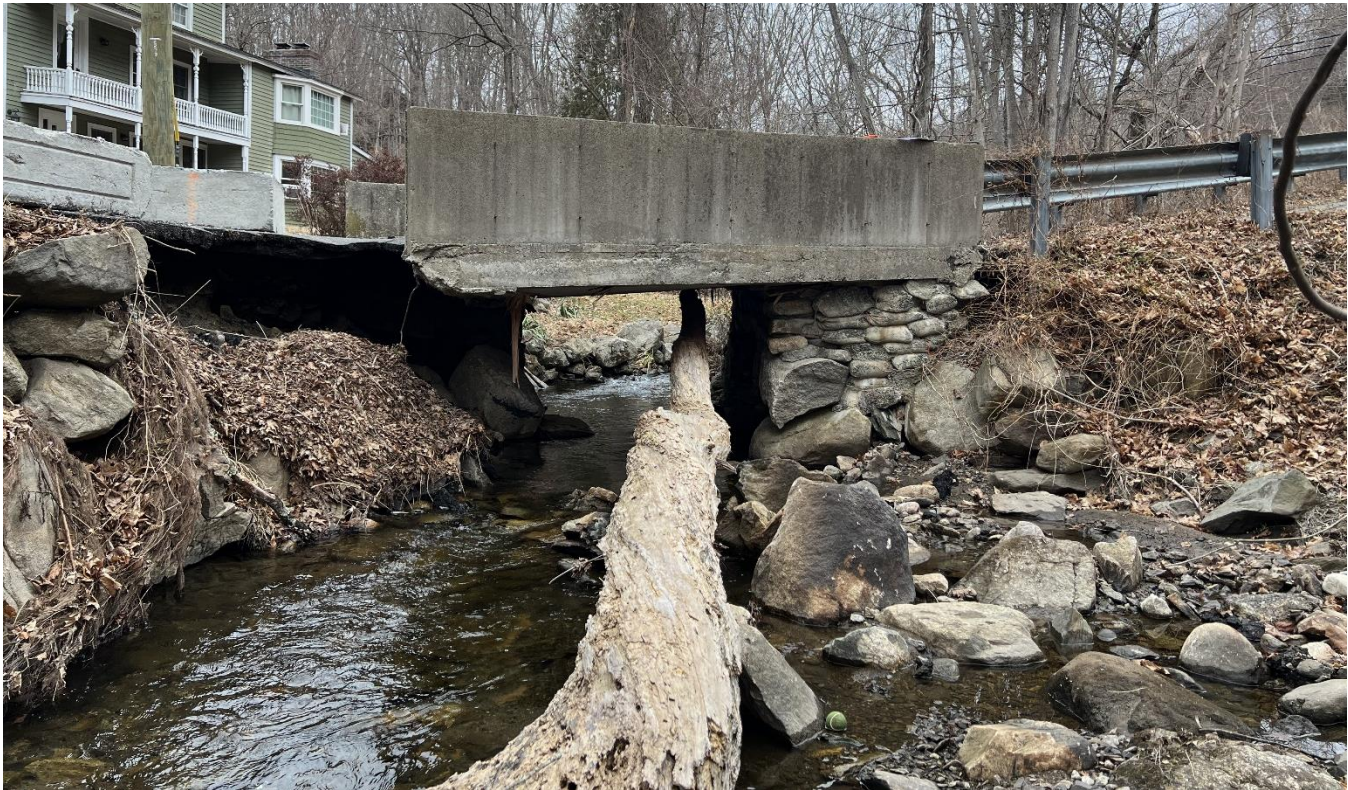
| Abutments - Wingwalls: | 0 | Stone masonry:<br>- The southwest wingwall was washed away along with the abutment.<br>- The remaining three wingwalls appear in satisfactory condition. |

Photo Number: 6 South (downstream) elevation.  
Note missing abutment, wingwall, and backfill at southwest corner. Photo Taken: 03/14/2025

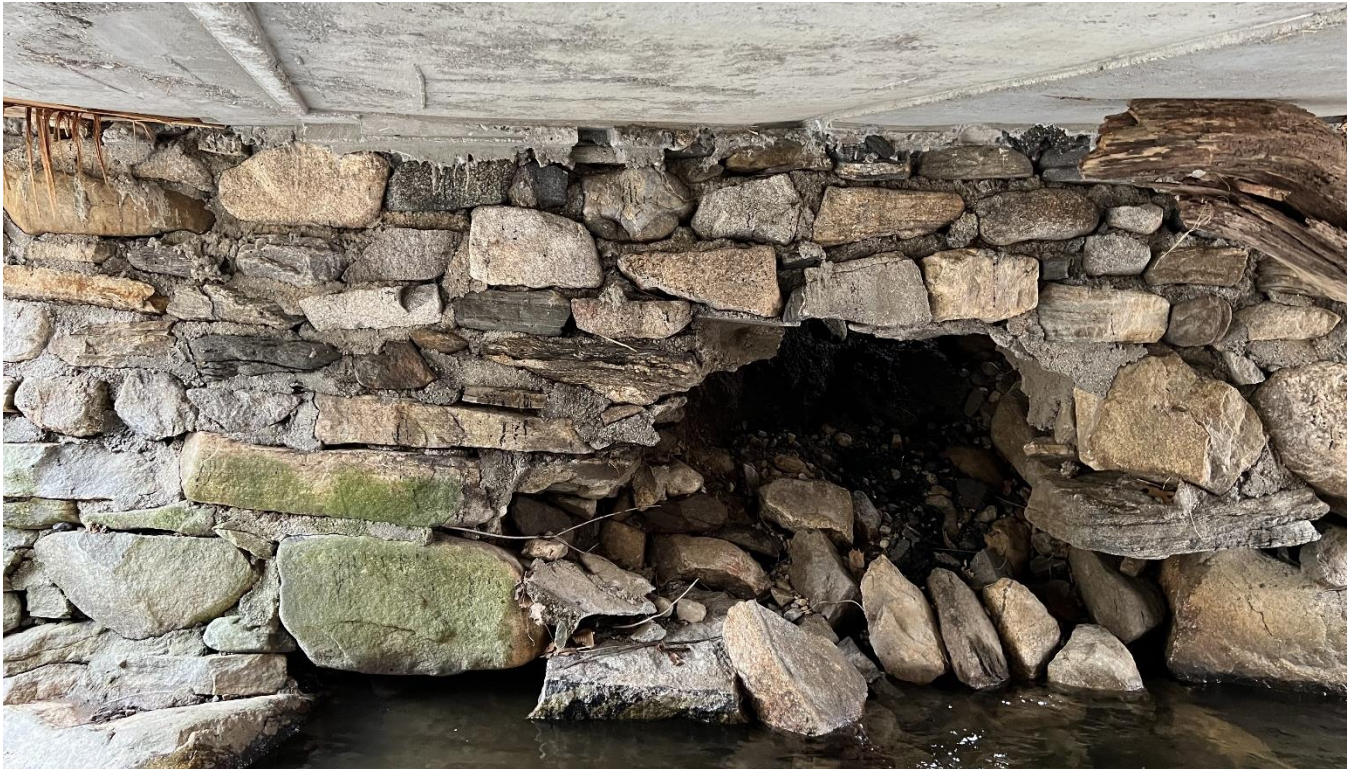
Photo Number: 9

East abutment. Note collapse with daylight visible through southeast wingwall.

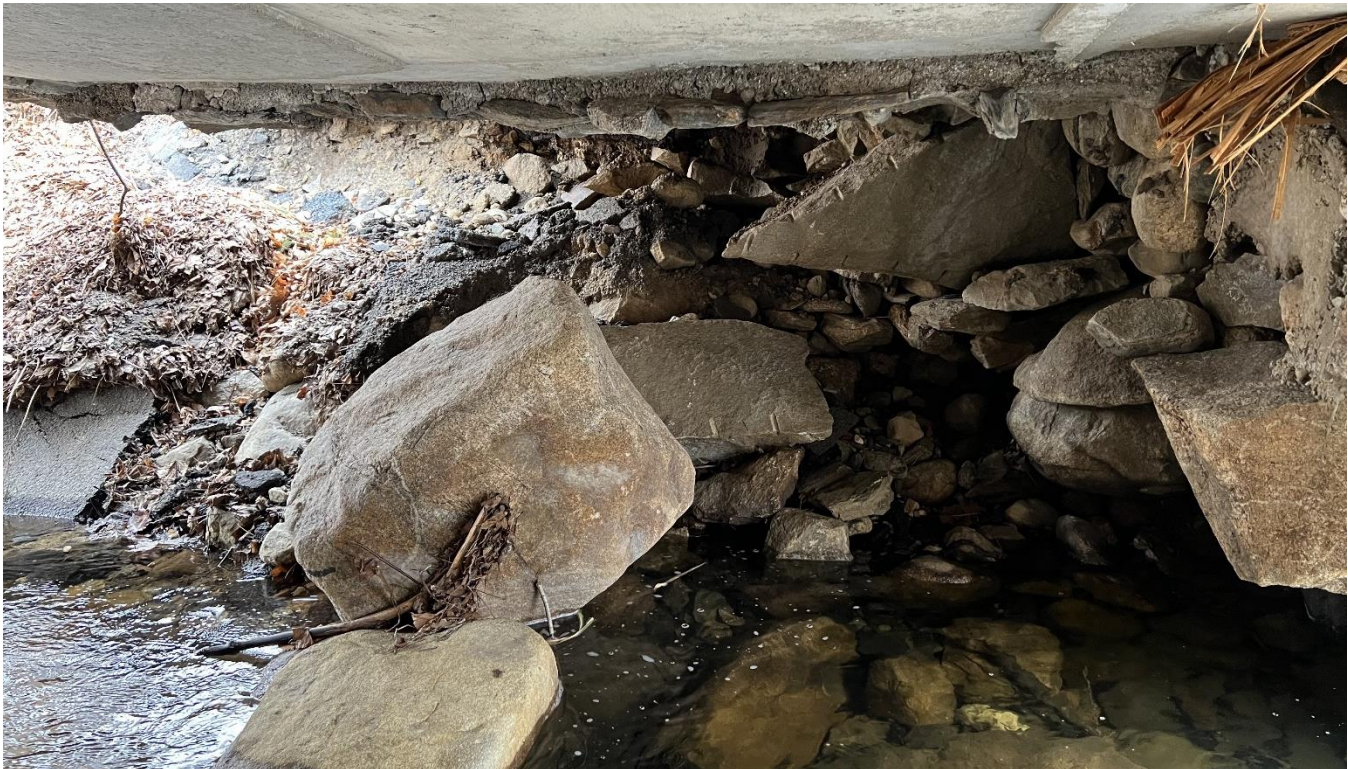
Photo Number: 10

| Abutments - Stem: | 0 | Stone masonry:<br>- The southern (downstream) 80% of the west abutment was washed out and completely lost. Stones that appear to have been part of the abutment stem are strewn along the streambed downstream.<br>- The center of the east abutment was also washed out.<br>- Both abutments are in a failed condition, leaving little support for the concrete slab superstructure. Additional erosion/washout may result in the superstructure falling into the channel. |

West abutment. Note southern 80% of abutment collapsed/washed downstream.

Based on the conditions noted above, repair is infeasible and complete replacement with a scour-resistant structure is recommended. The most logical structure type is a two-cell precast concrete box culvert. The approximate construction cost of a structure of this type and size is \$1.5 million. Concept plans and a detailed estimate are provided in the Town's funding application to the State Local Bridge Program.

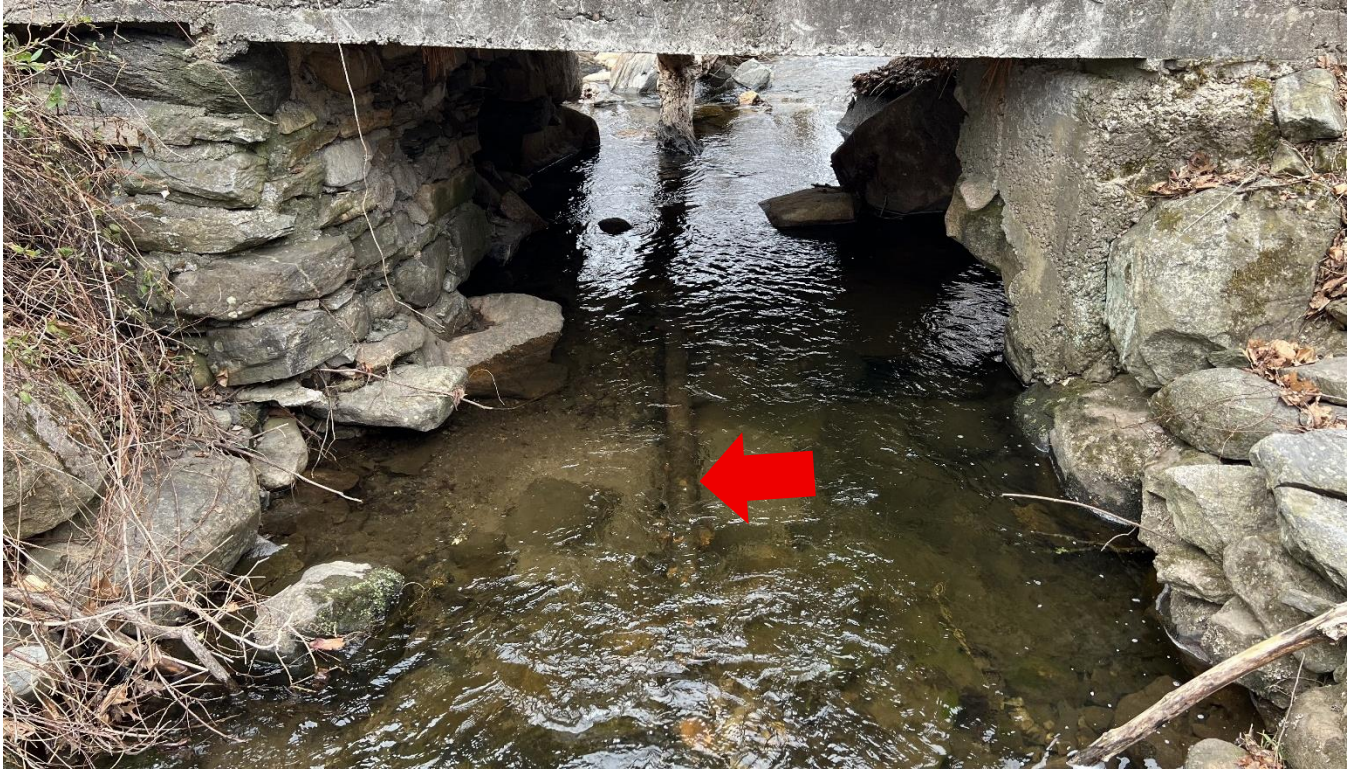
Photo Number: 11    Abandoned utility pipe resting on streambed    Photo Taken: 03/14/2025  
(looking downstream).

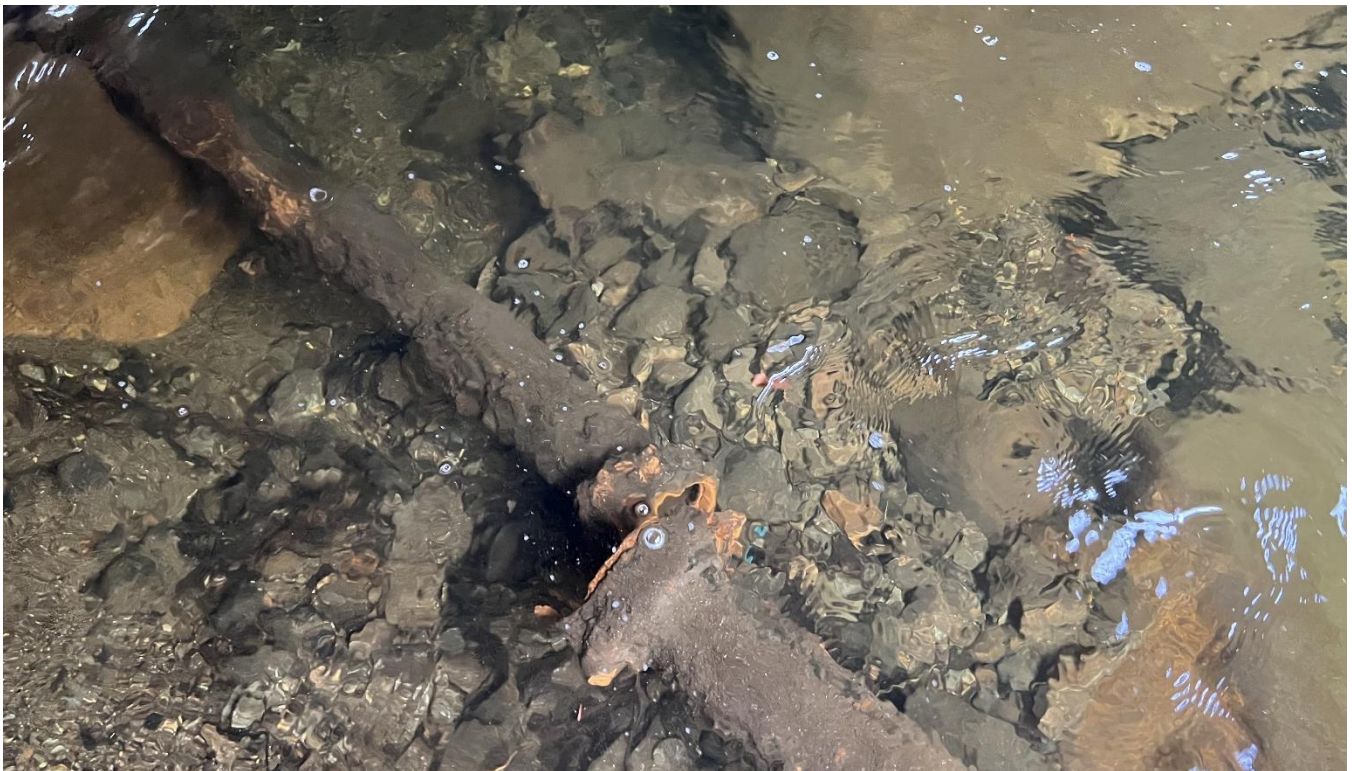
Photo Number: 12    Abandoned utility pipe, with break in pipe    Photo Taken: 03/14/2025  
clearly visible beneath bridge.
